Portland Harbor RI/FS

Remedial Investigation Report

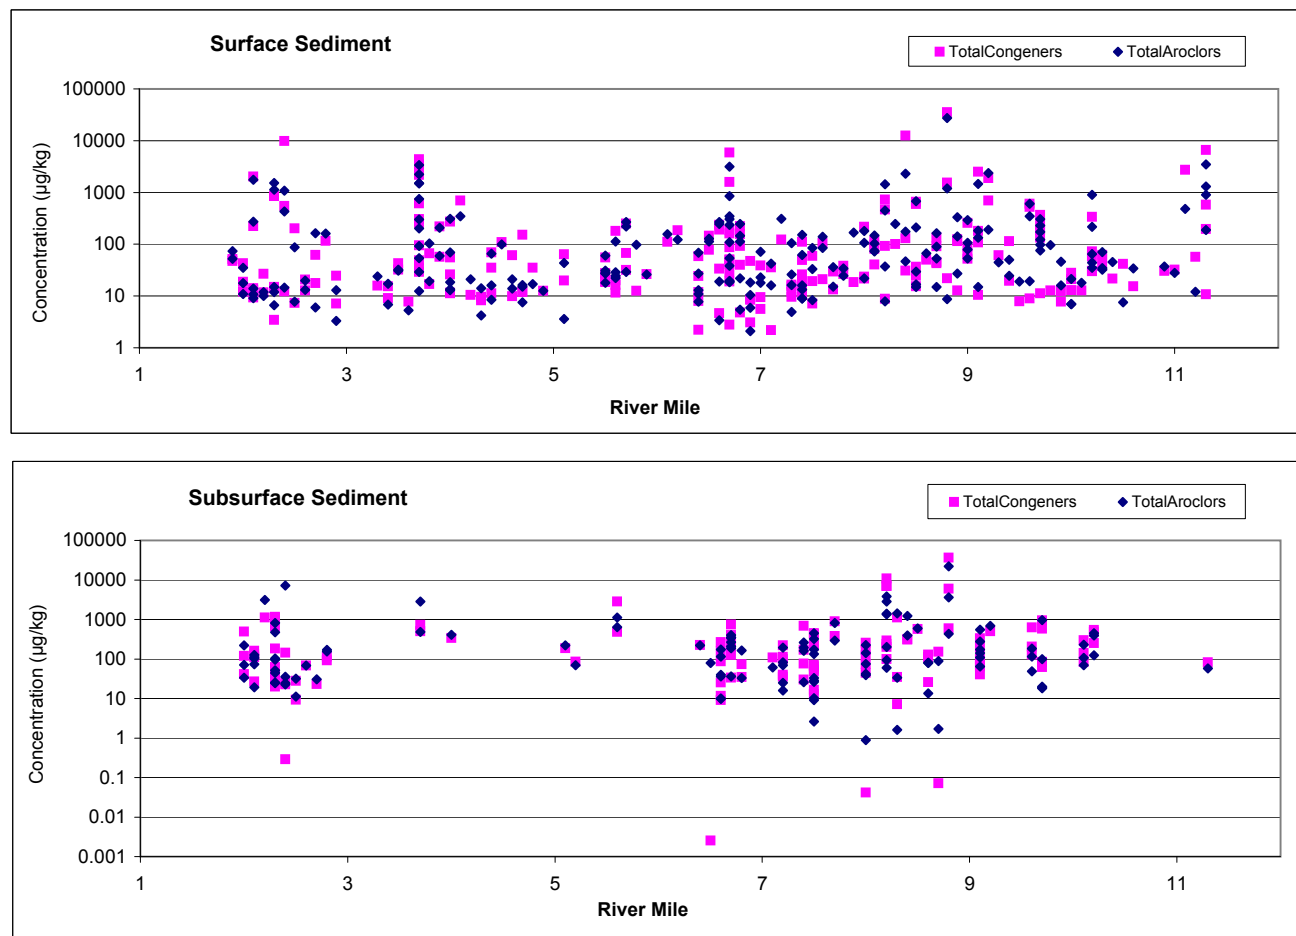
Figure D1.5-1a
 Portland Harbor RI/FS
 Remedial Investigation Report
 Scatter Plots of Total Aroclor and Total PCB Congener Concentrations
 In Study Area Sediment, Biota, and Sediment Trap
 Samples Analyzed by Both Methods

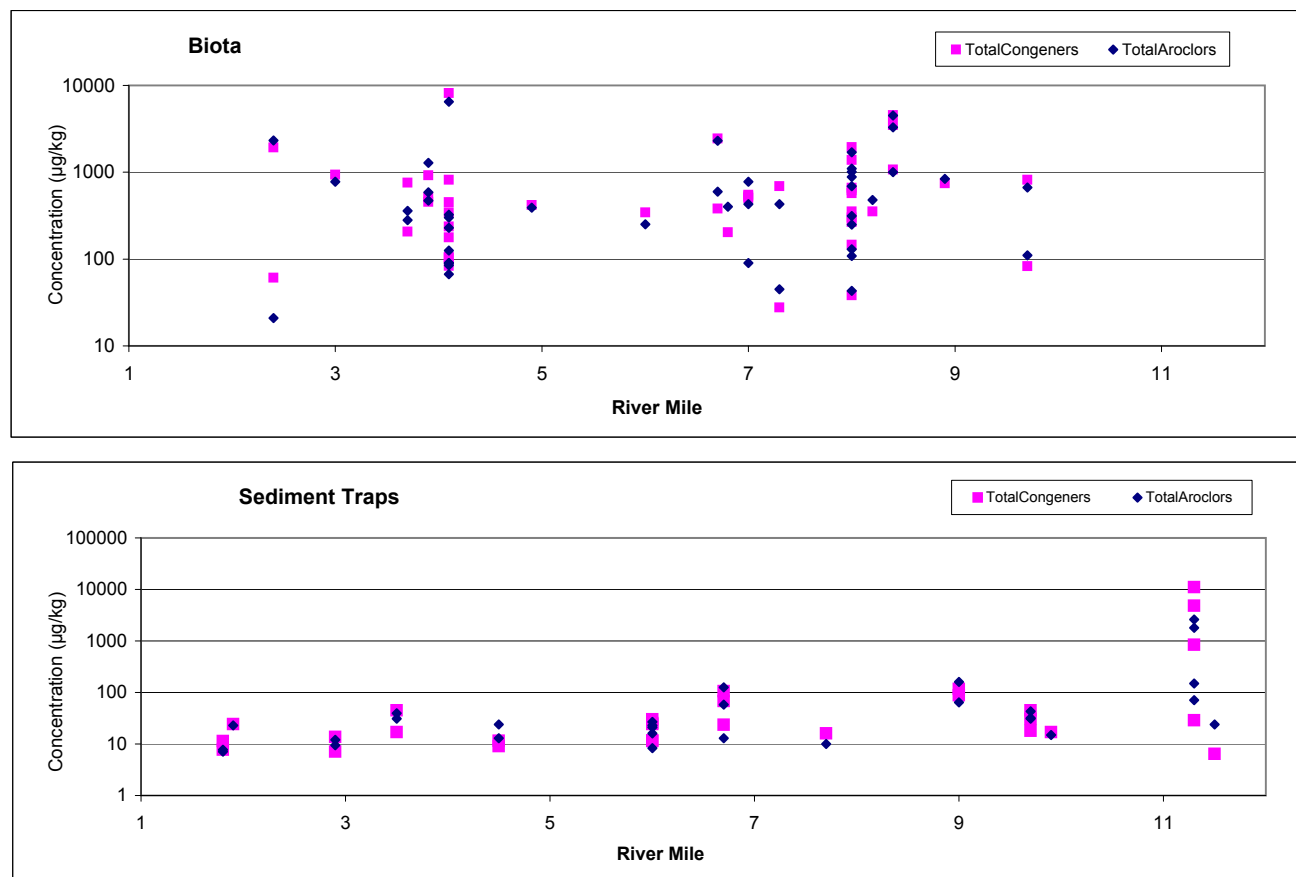
Figure D1.5-1b
 Portland Harbor RI/FS
 Remedial Investigation Report
 Scatter Plots of Total Aroclor and Total PCB Congener Concentrations
 In Study Area Sediment, Biota, and Sediment Trap
 Samples Analyzed by Both Methods

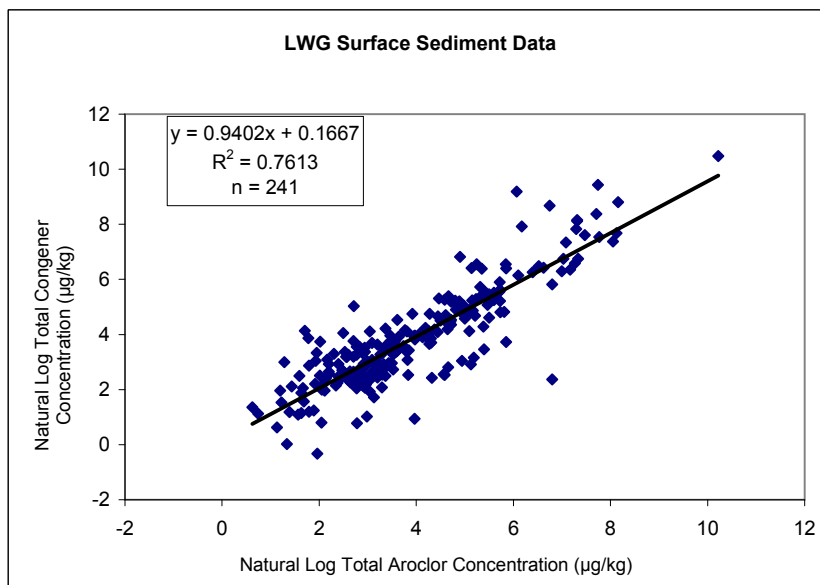
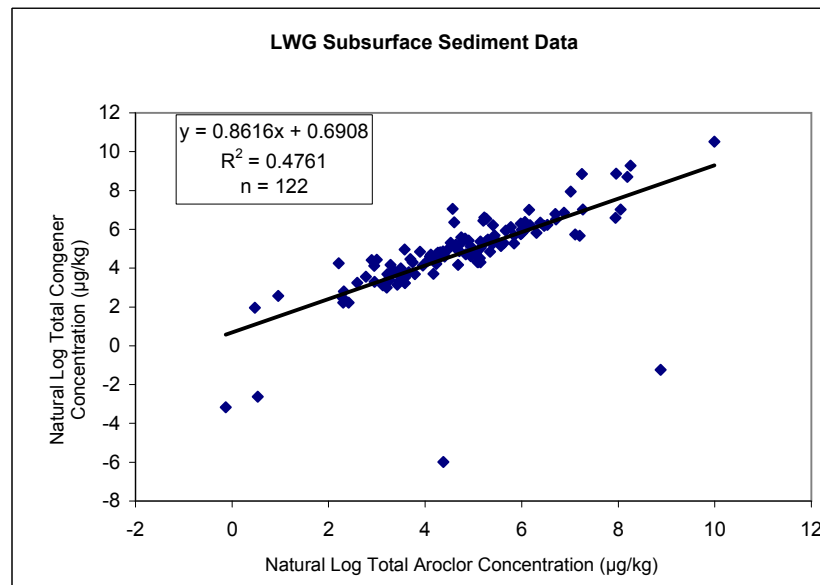
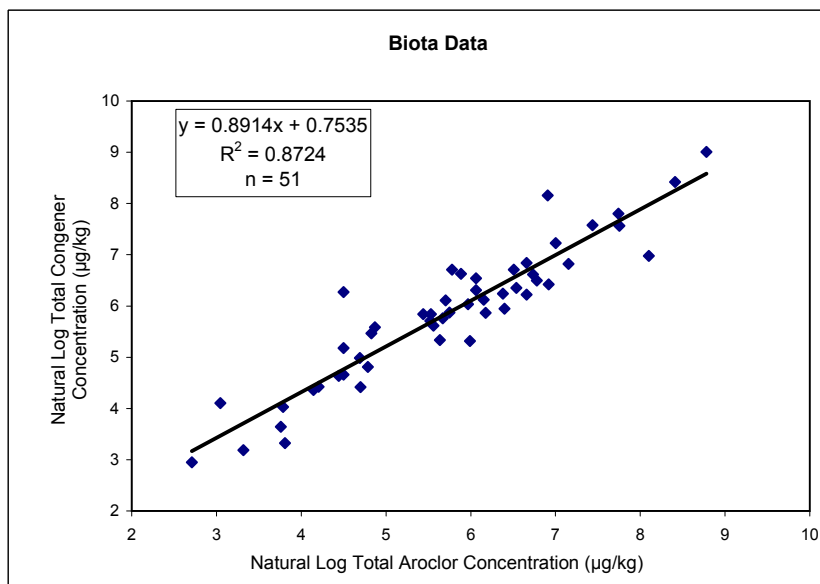
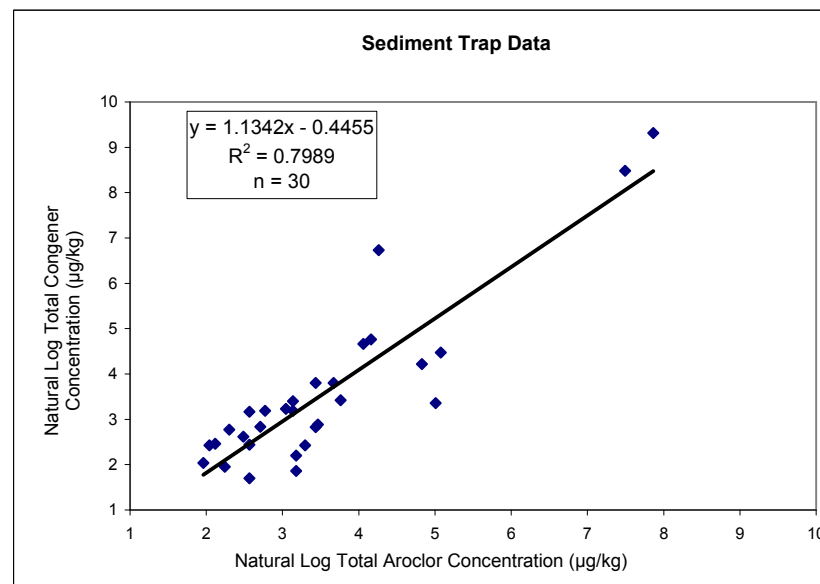
Figure D1.5-2

Correlation of Aroclors and PCB Congeners in

Surface and Subsurface Sediment, Sediment Traps, and Biota

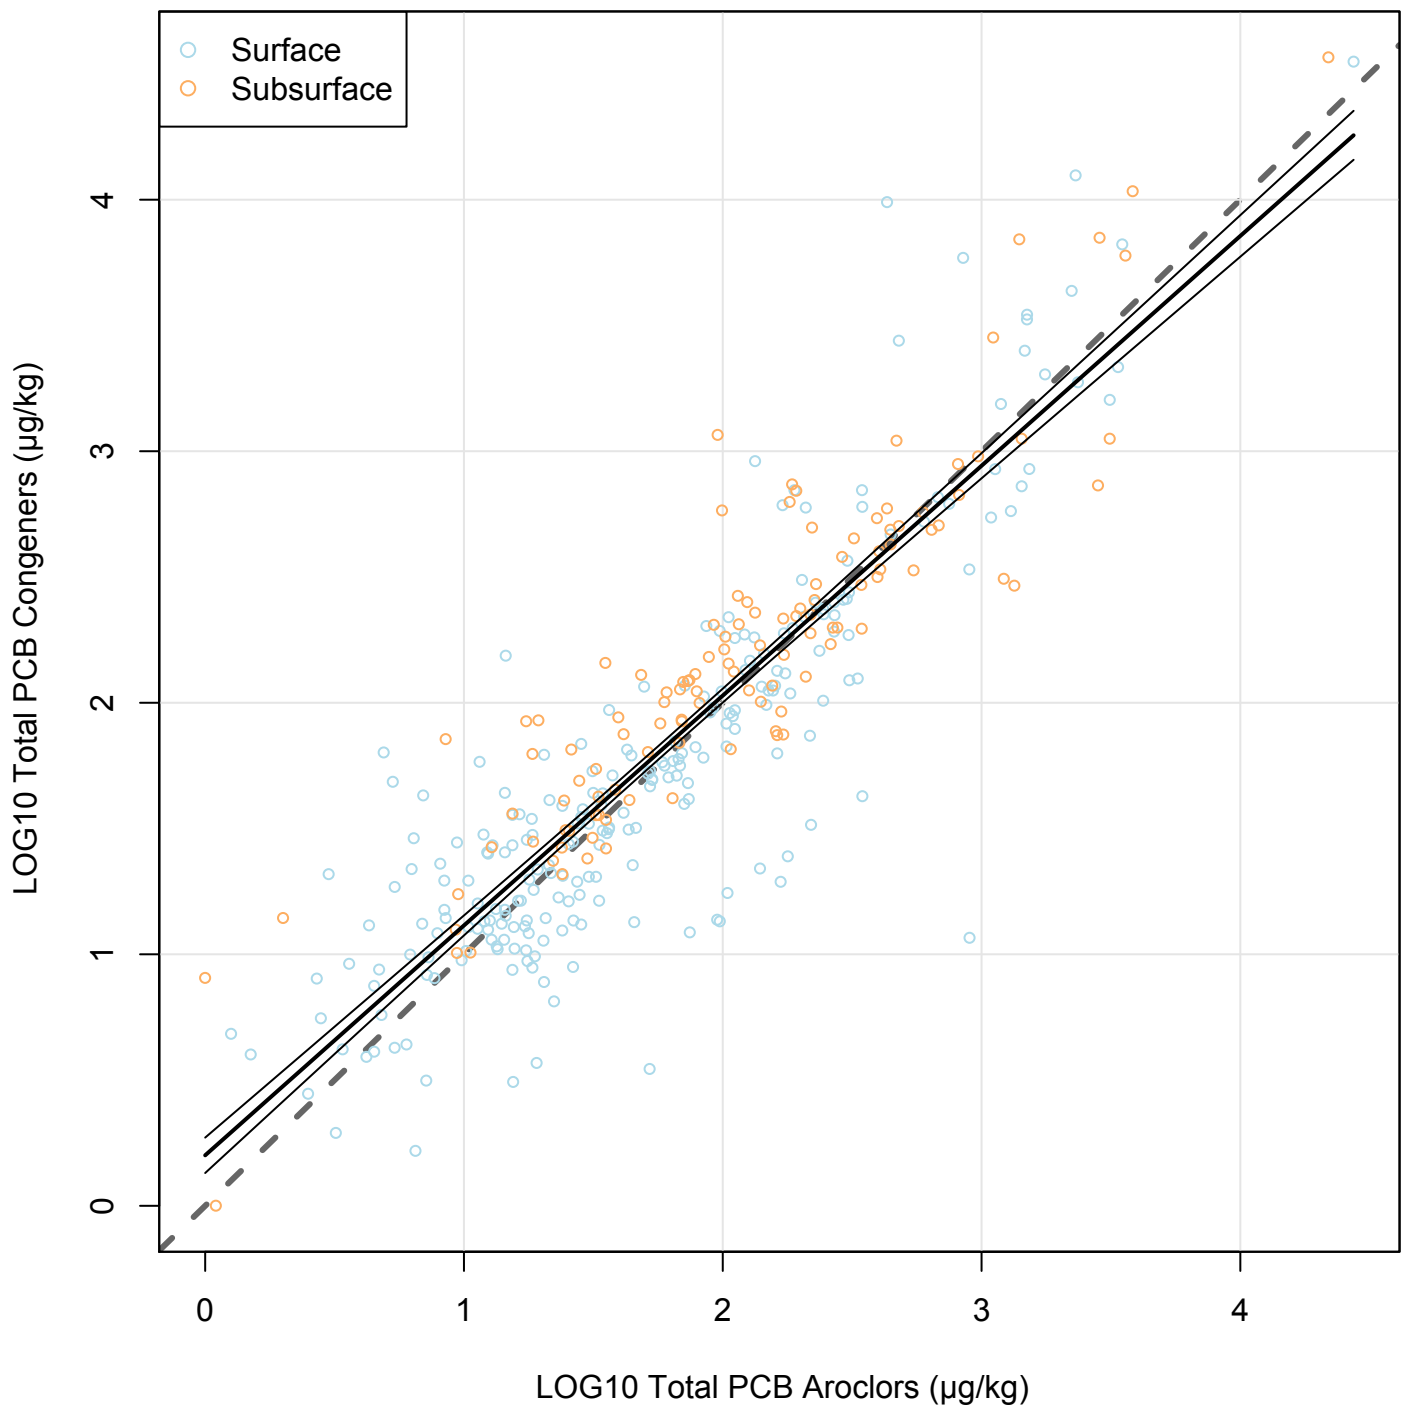
Figure D1.5-3

Regression of Total PCB Congeners and Aroclors with
95% CI (solid lines) and the 1:1 line (dashed)

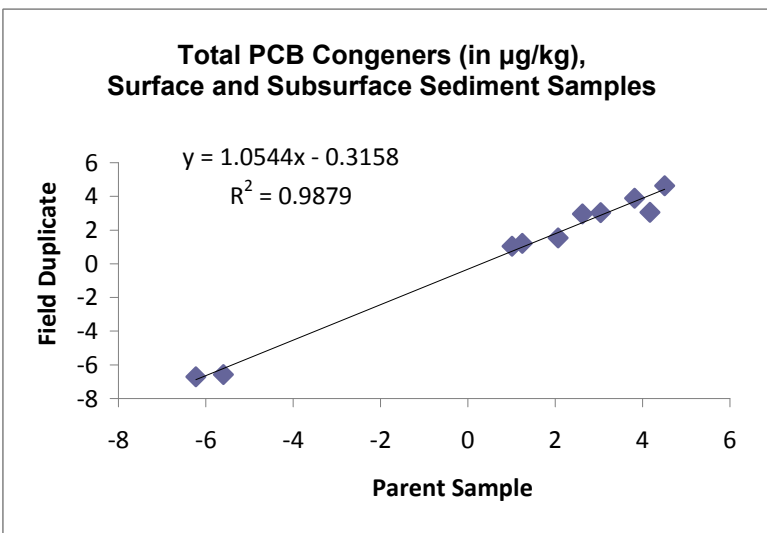
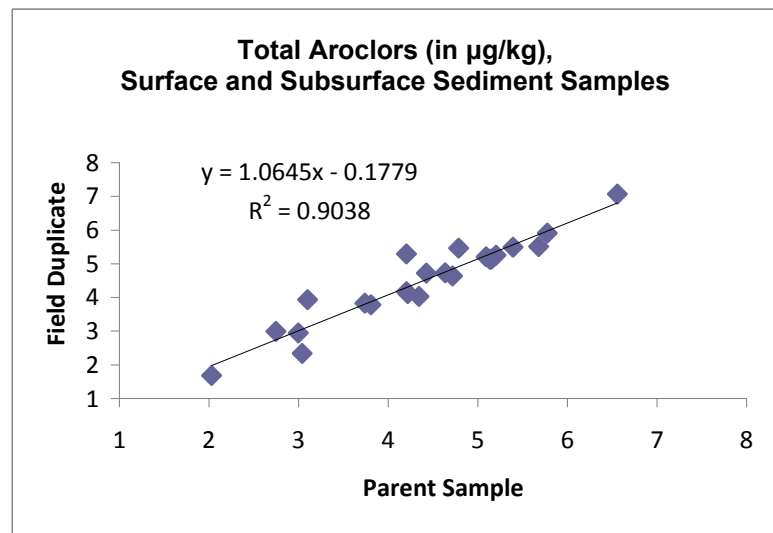
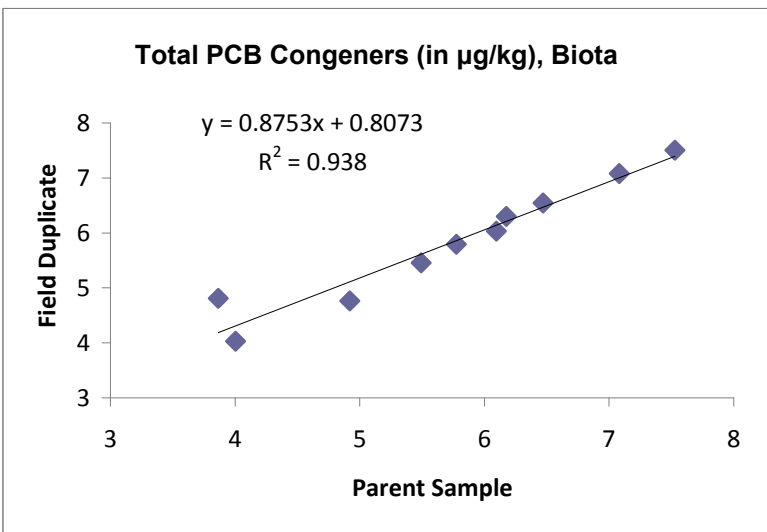
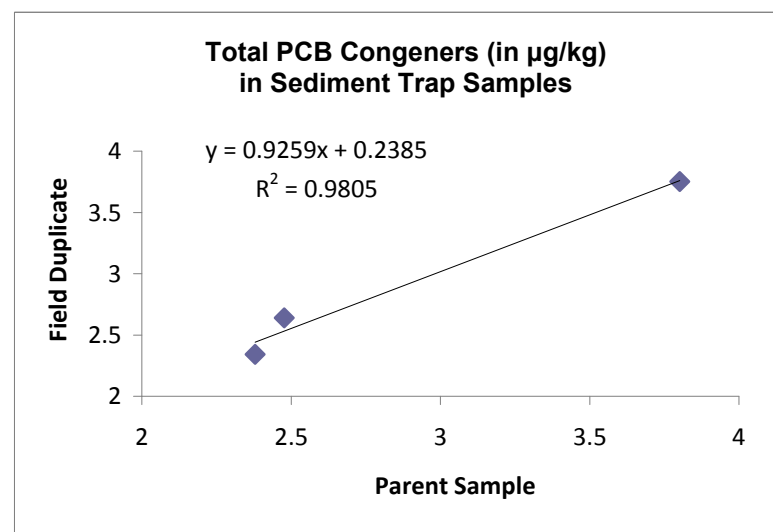
Figure D1.5-4
Portland Harbor RI/FS
Remedial Investigation Report
Correlation of Total PCBs in Field Duplicate Samples
